# **EARTHRINGS™**

VFD ELECTRIC MOTOR BEARING PROTECTION

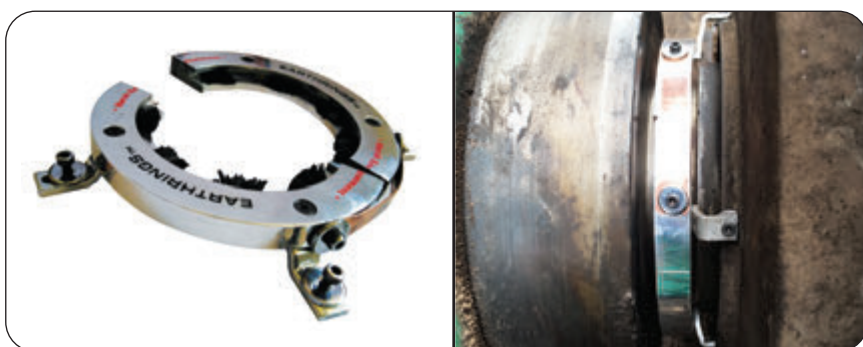
### **Split-Earthing**

These rings are available in LV and HV Earthings, and are used for on-site installations where removal of the coupling is not required. It comes with copper strip clamps on both sides to easily clamp the Earthing around the shaft before fitting. The Split-Earthing is well designed and extremely solid once it is closed (unlike many other options out there), which makes for easier fitting on-site as well as a much more solid alternative compared to other brands.

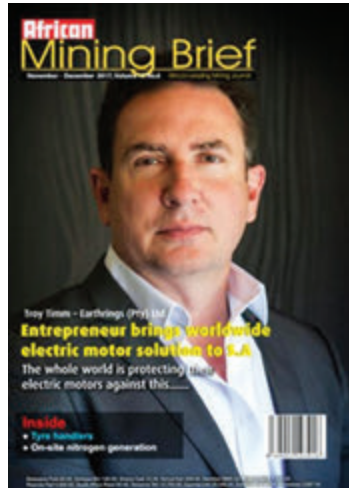
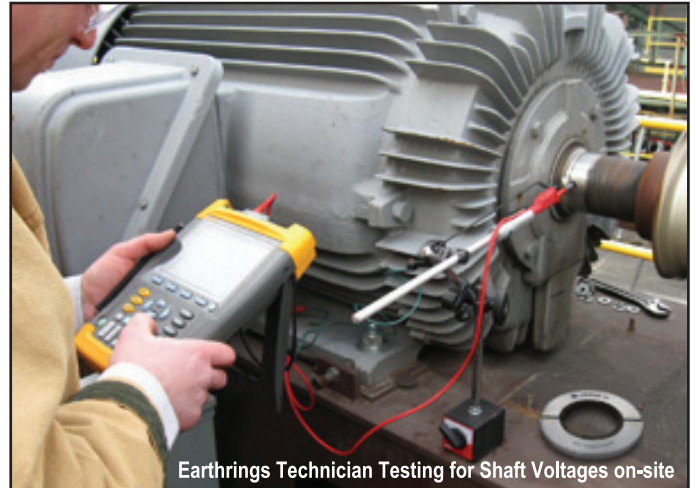
Earthrings Technician Testing for Shaft Voltages on-site
